April 23, 2009

Pipeflo crew takes a close look at deeply buried Hamilton sewer line

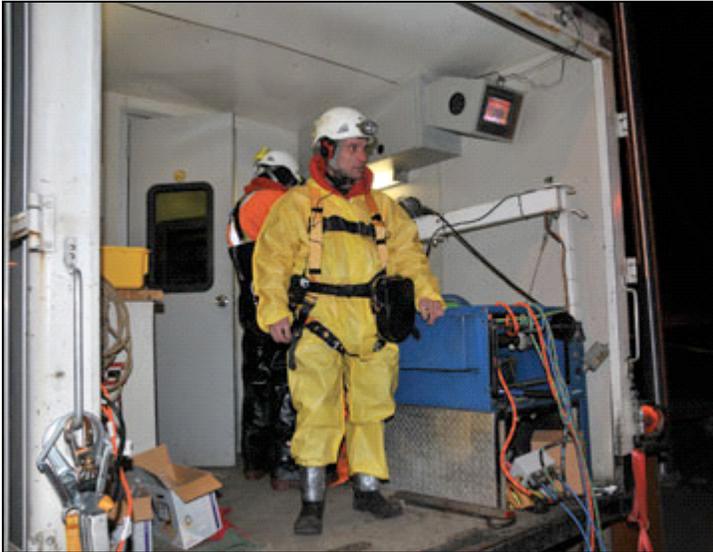
Crews from contractor PipeFlo entered a 25-metre-deep shaft to inspect a cracked sewer line while staying in voice contact with a surface unit.

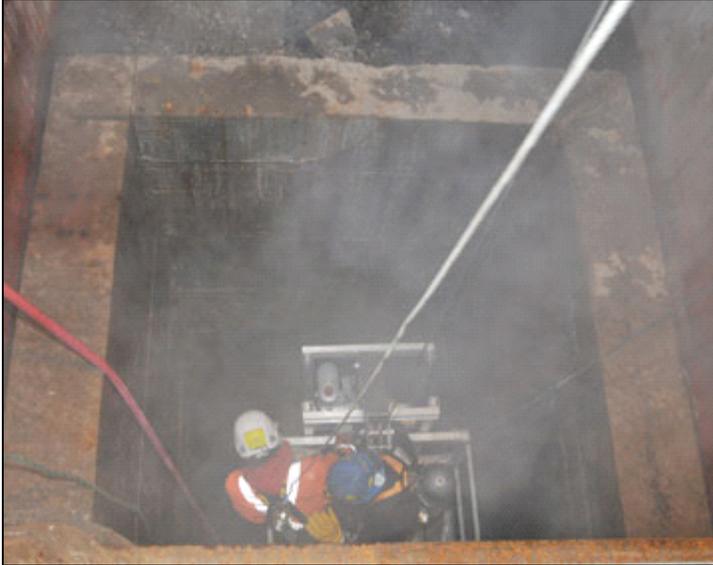
An underground view of the pipe inspection process.
