June 29, 2007

Side Scanning revolutionizes pipe inspection

System provides accurate picture

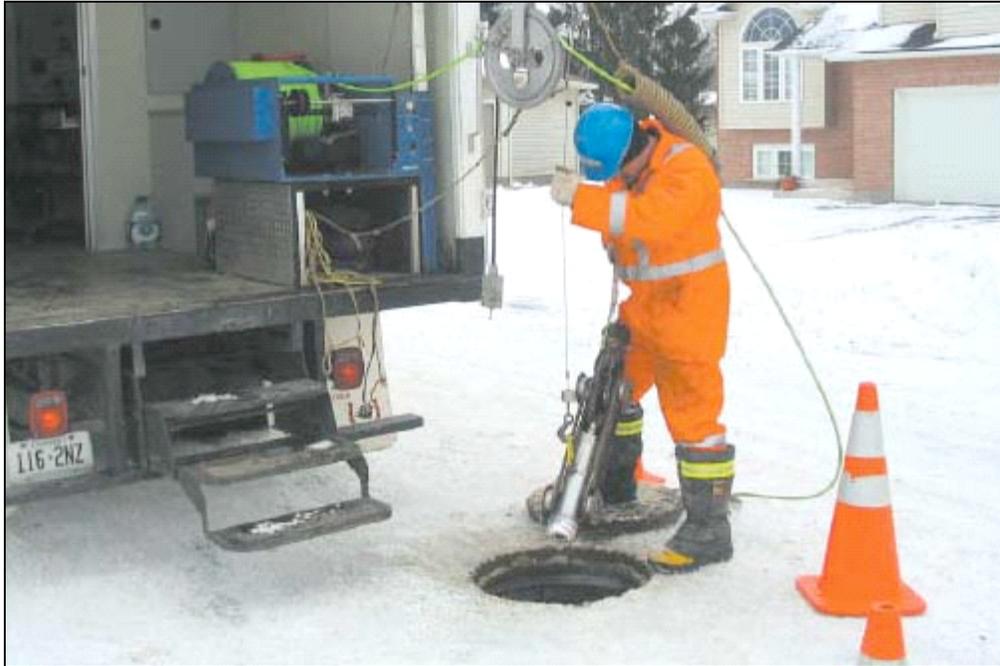
Technicians prepare to feed Canada's first Side Scanning Evaluation Technology into a water system for inspection.

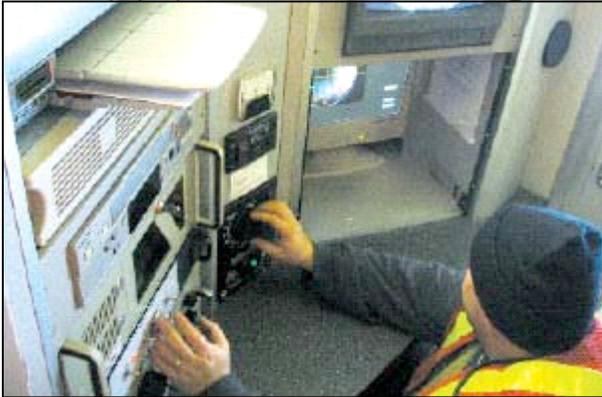
SSET can be remotely controlled from a truck parked at the entry point of the system inspection.

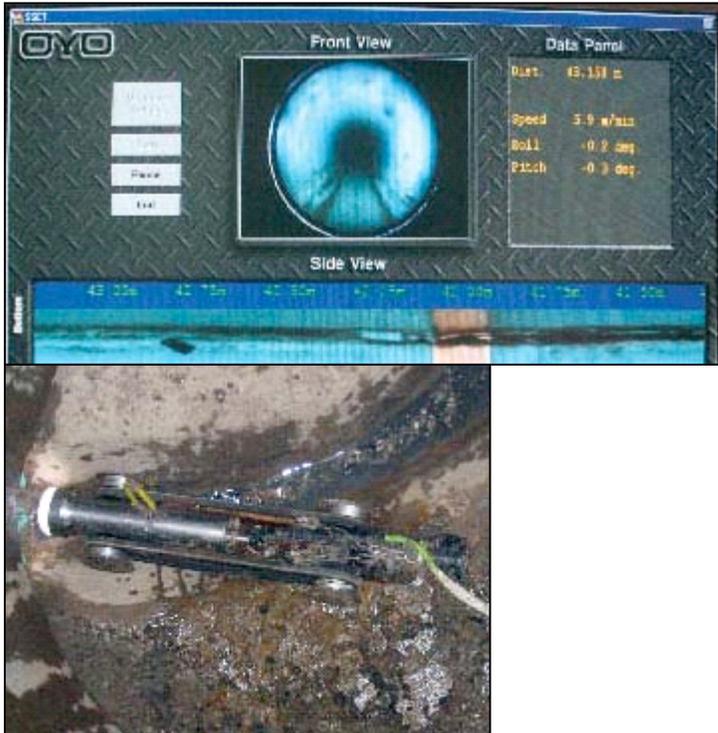
Pictures from SSET are fed remotely directly to computer screens where experts can evaluate the state of water pipes.
